Manhole Inspection Summary

Manhole # S21Y__009MH

Insp Date: **11/21/08 1:15 PM**

Location Address: **2102 MAISEL ST**

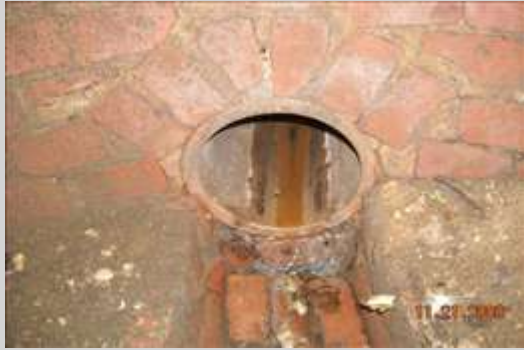
9 O'Clock Inflow

8 in. Circular Gravity Sewer

Pipe In @ 9 O'Clock

Pipe Height: **8.4** (in.) Rod and Bar (Angled)

Pipe Material: **Clay** ☐ Pipe Lined

Infiltration: **None** Pipe Seal Cond: **Sound**
